TECHNICAL SERVICE BULLETIN

SUBJECT:
MPI CIRCUIT IN MONTERO SERVICE MANUAL – SERVICE MANUAL REVISION

NO. TSB-89-16-001
DATE June, 1989
MODEL Montero

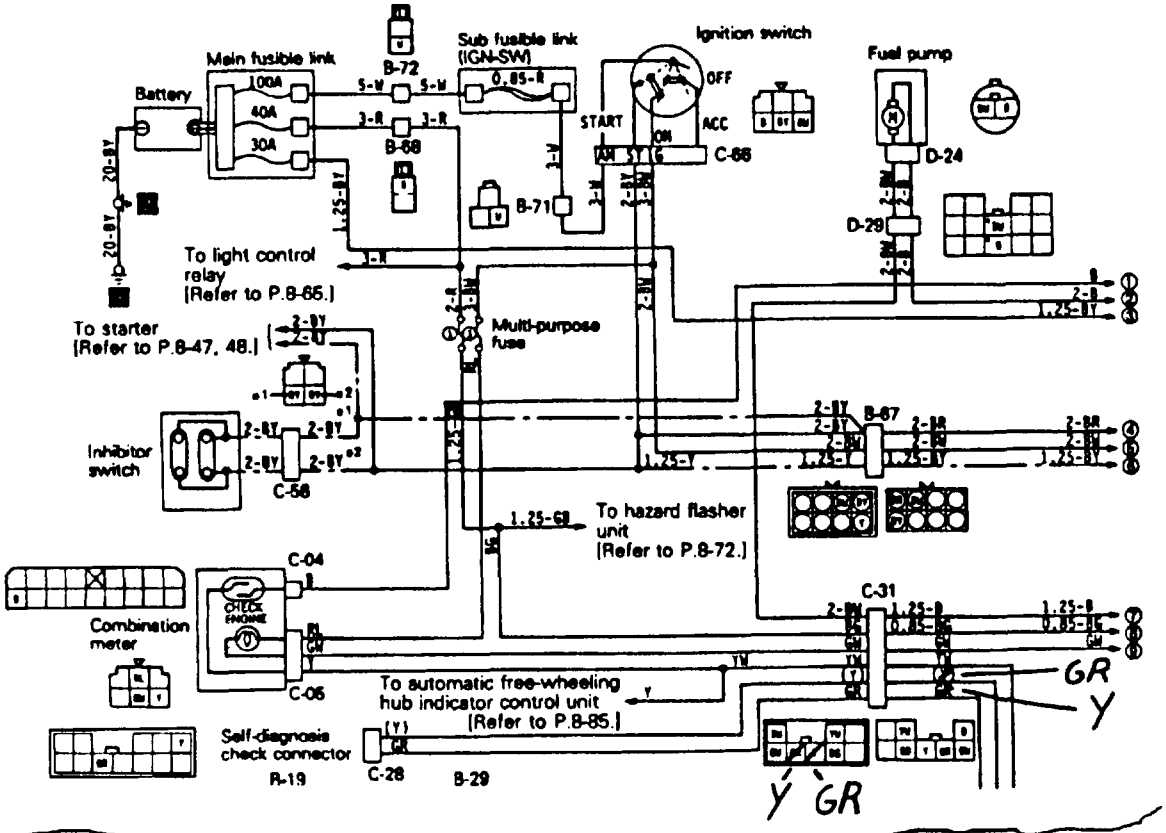
8-56 **WIRING HARNESS – M.P.I. Circuit**

This bulletin describes a correction to the 1989 Montero Service Manual. The Service Manual has typographic errors in the identification of two wire colors. As a reference to this bulletin, write the TSB number in the TSB Revision Box at the bottom of the affected page.
